Corrosion Deposit

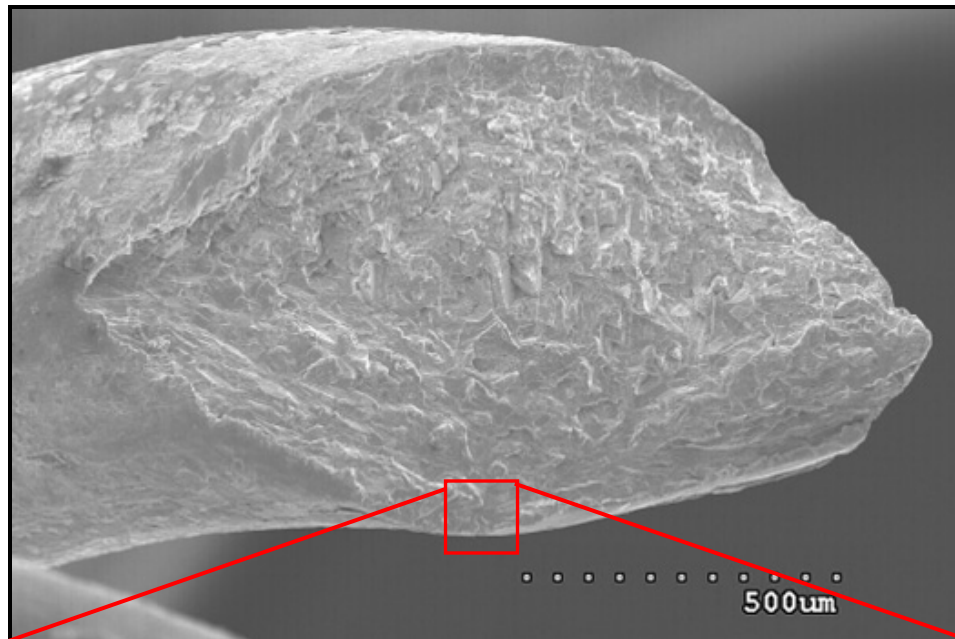
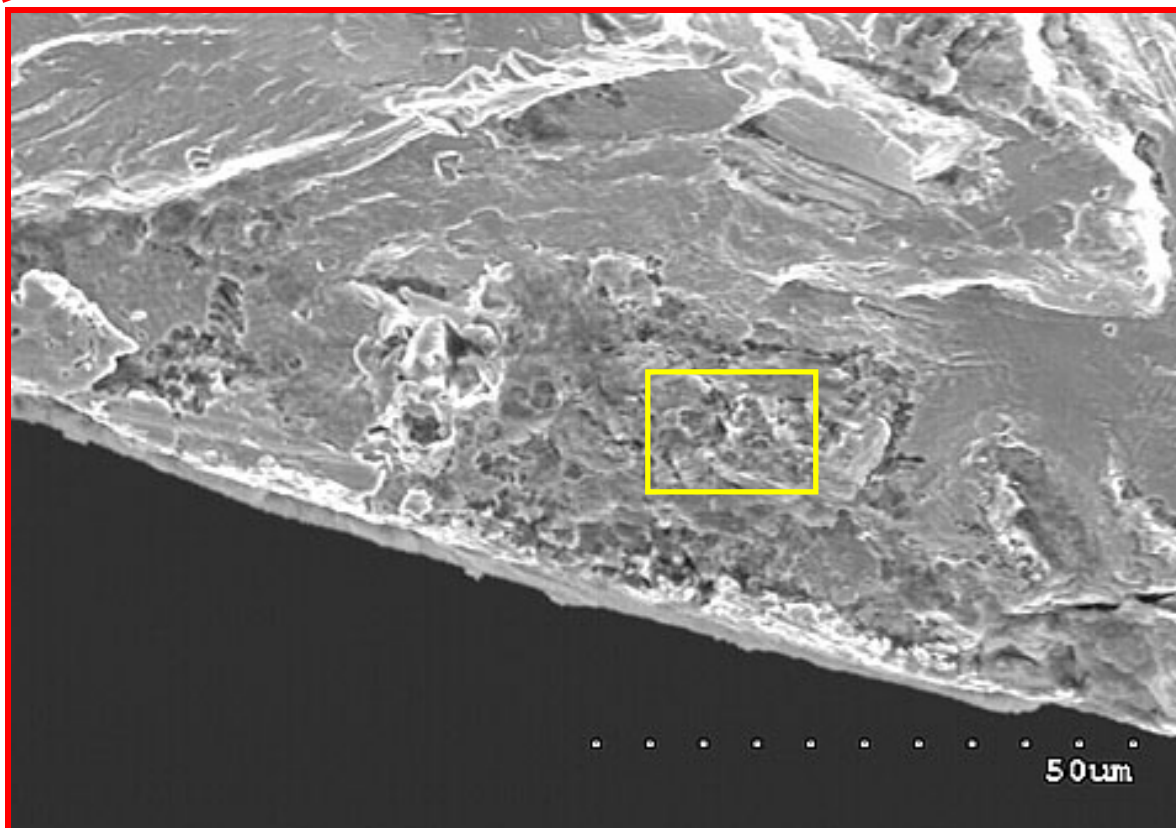
Figure 1: The presence of corrosion was apparent at the crack origin of a torsional fatigue fracture on a high-temperature alloy spring. An Energy Dispersive X-Ray Spectroscopy (EDS) was done on the area in the yellow rectangle. The EDS results are presented in Figure 2.

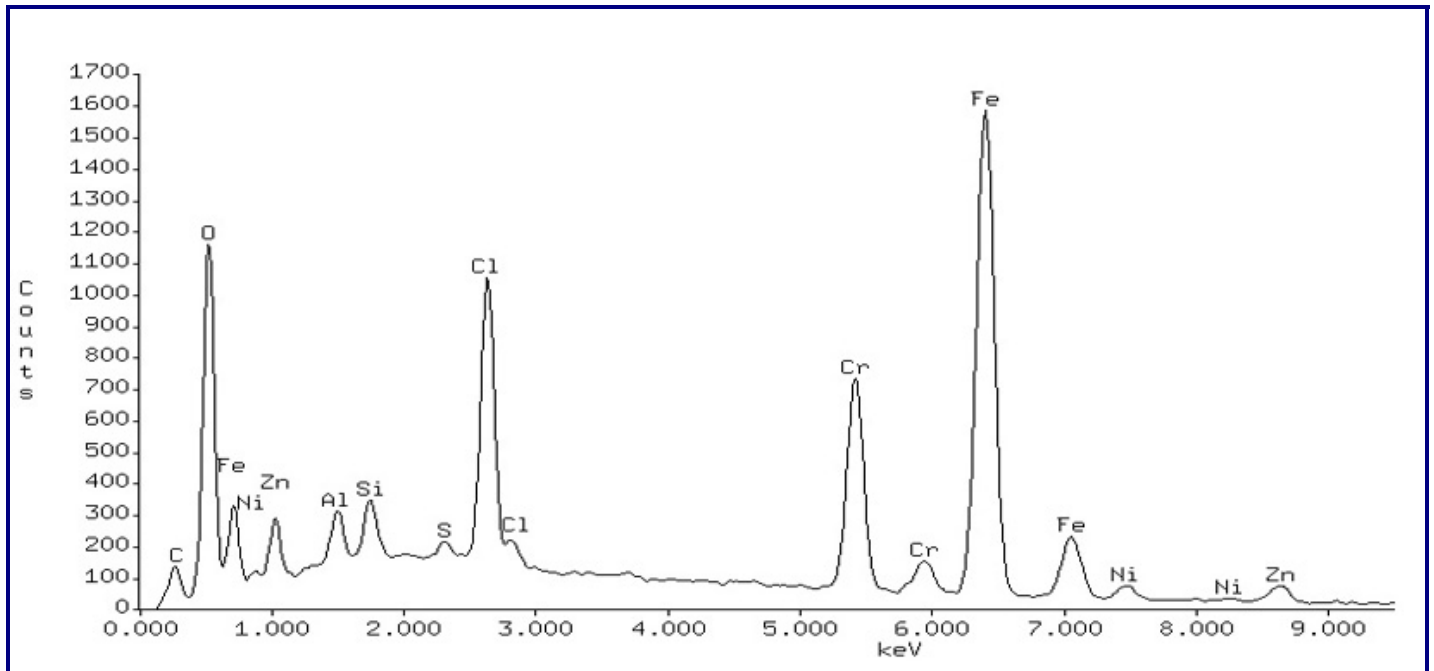
Figure 2: The EDS output from the oxidized/corroded area outlined in yellow from the figure above, containing a very strong oxygen and chlorine peak.
